Modification Instruction for:

* Improvement of frequency response of early 24 channel recorders.

** Elimination of spike noise of A80-VU recorders.

- * Frequency Response 24 Channel
- ** Spike Noise

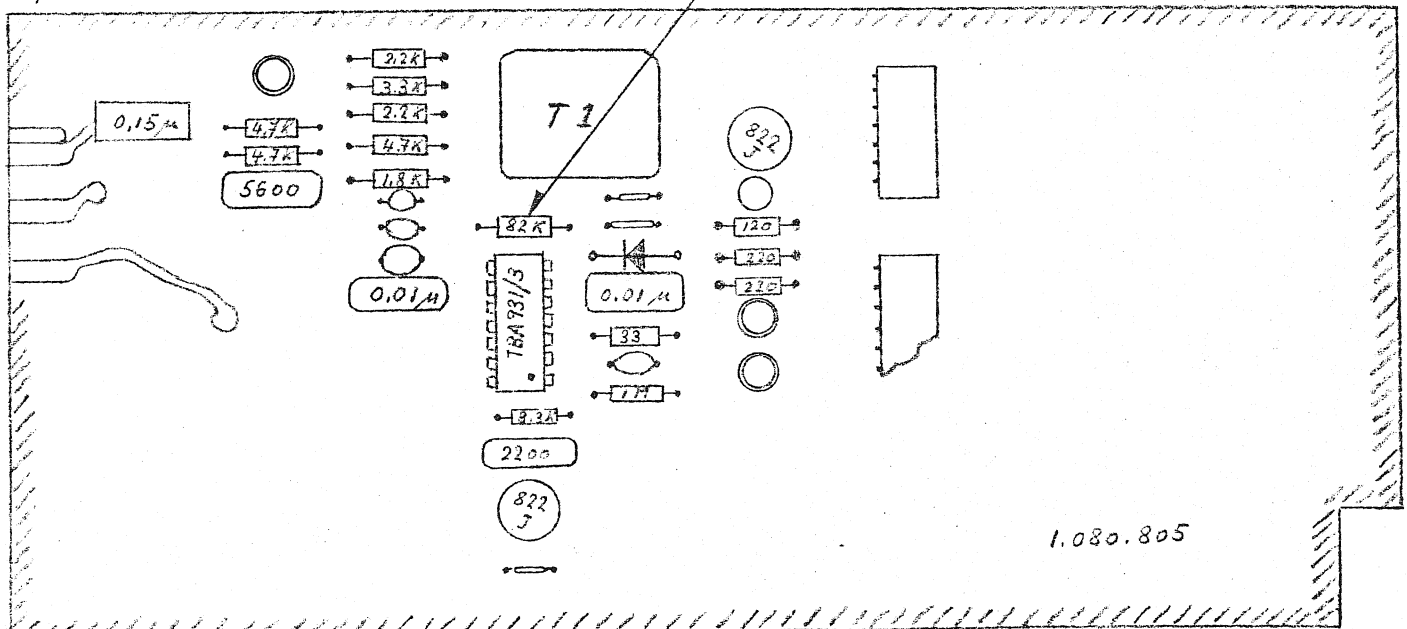
1. It has been found that the early 24 channel A80 recorders have a high frequency roll-off in the reproduce and sync channels. The cause of this short coming has been found in the too low value of the resistor across the secondary winding of the input transformer.

* substitute 82 KΩ resistor by a 180 KΩ resistor

The 82 K.Ohm resistor near the input transformer T1 must therefore be changed to 180 K.Ohm.

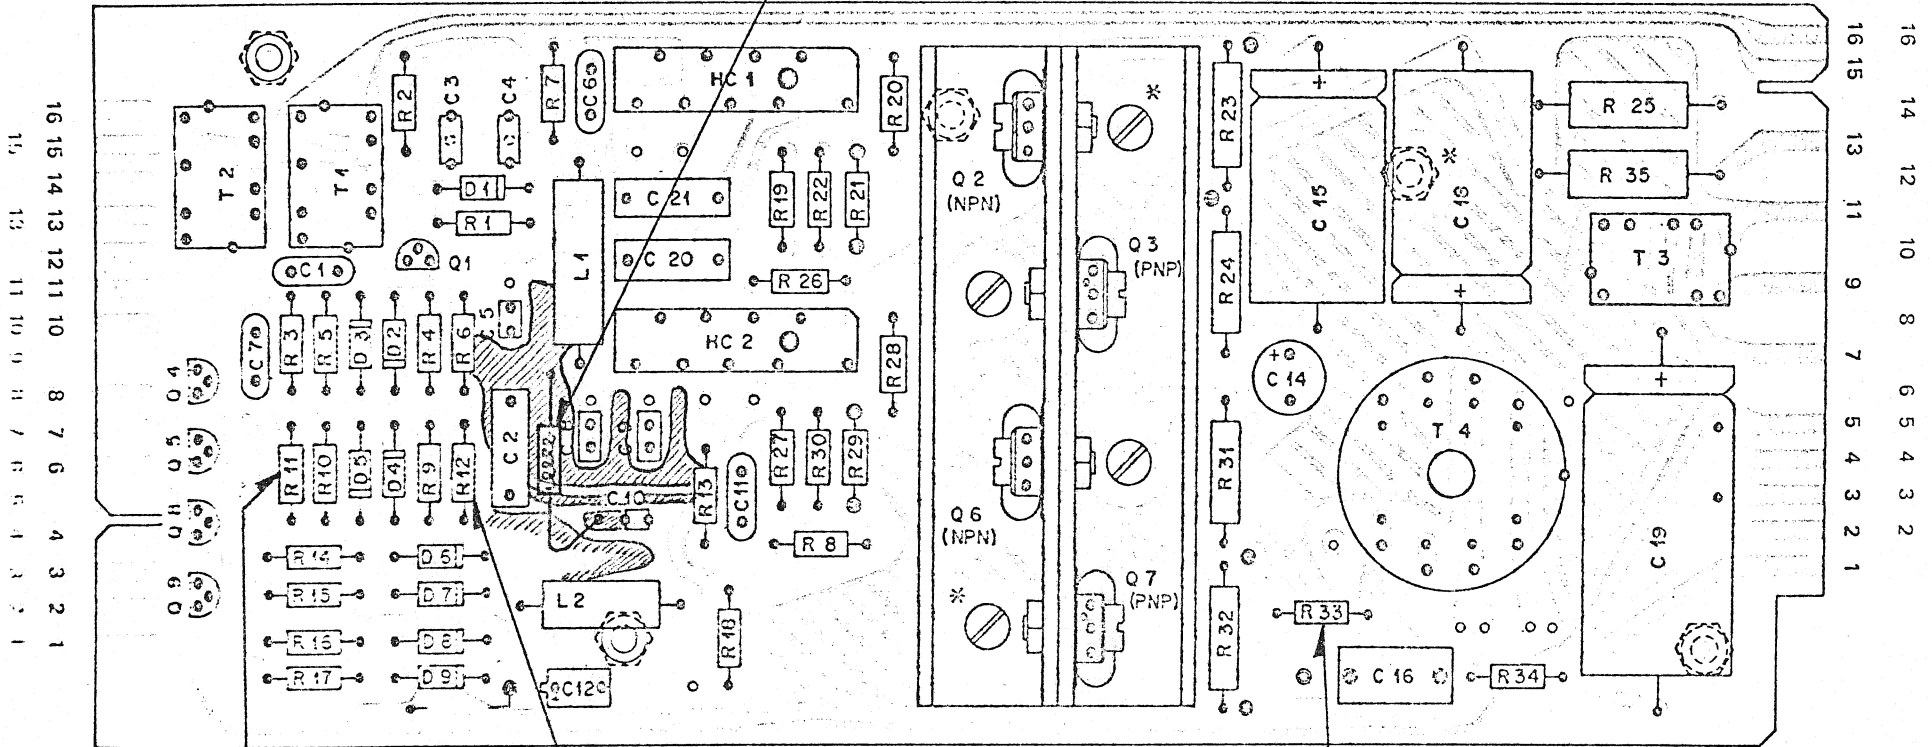
2. Under certain conditions it may occur that 100 Hz spikes are being recorded on the tape. These spikes may be as much as 6 dB above the tape noise.

** Insert additional 8.2 mH choke

** substitute R11 (2.2K)
** by a 4.7K resistor

** substitute R12 (2.2K)
** by a 150pf capacitor

* substitute R33 (10Ω)
* by a 4.7Ω resistor

In addition it is recommended to change R33 (10 Ohm) on record driver p.c.b. 1.080.872 to 4,7 Ohm.

This problem can be eliminated by the modifications on the record driver card 1.080.881 marked (**).
