## AES/EBU Interface Causes Pops and Clicks

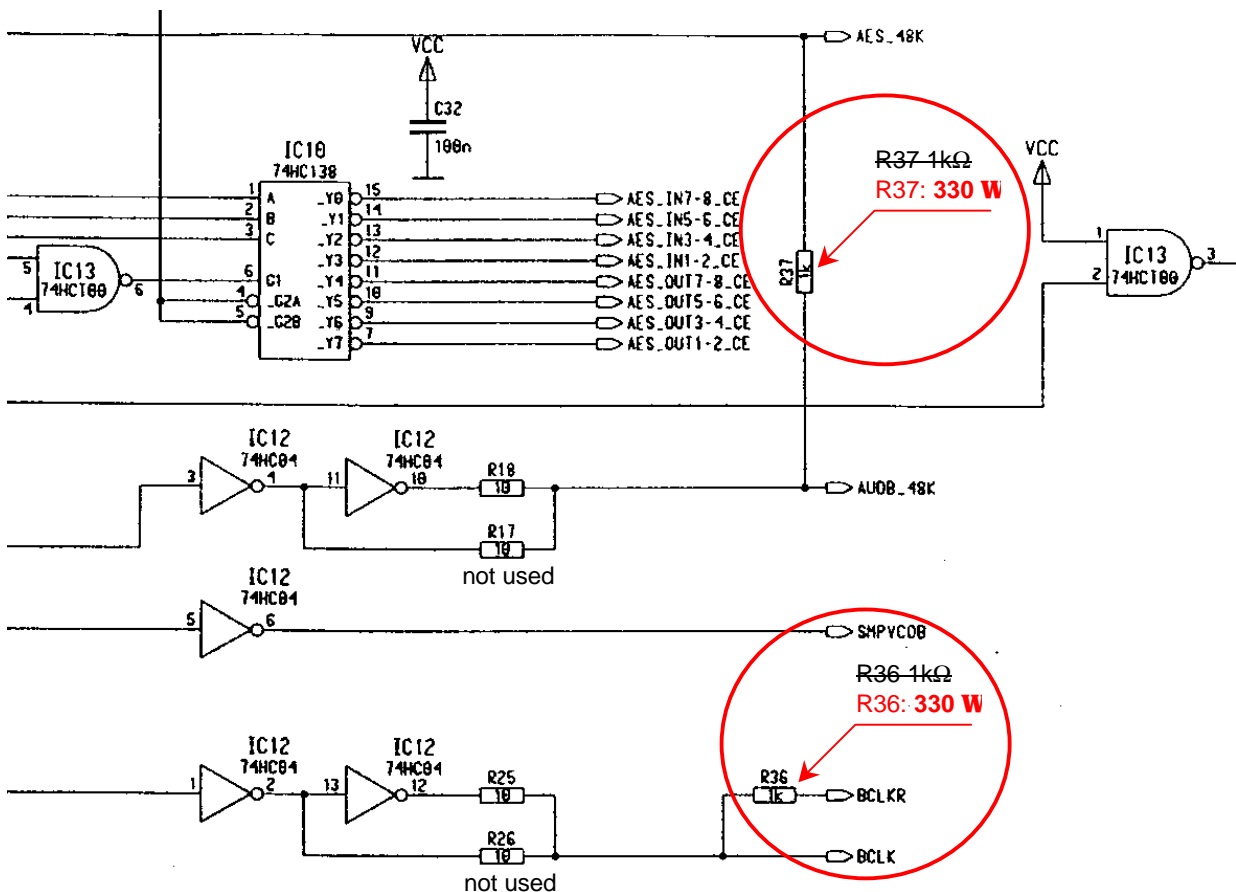
The optional AES/EBU interface 1.864.170.00 can exhibit clicks, pops or other audible noise when used in a machine configured as slave. The interface in the master machine always operates correctly. The phenomenon frequently occurs with the last unit in a chain of, say, three units linked for use as a 24-channel machine. The following procedure completely solves the problem. It is recommended that all available interfaces should be modified.

**AES/EBU Interface 1.864.170.00 diagram, partial view. After modification, the assembly is called 1.864.170.81 (i.e., modification index "81").**

1. *Separate the unit from the mains supply.* Remove the AES/EBU interface completely. It is accessed from the top of the machine. Remove the unit's top cover (6 Allen-head screws).
2. The AES/EBU interface is now freely accessible and can be removed by unscrewing the four screws (Allen key no. 2) from the rear. Carefully unplug the flat cable on the AES/EBU interface. Both free-wired resistors R36 and R37 (1 kΩ each) must be replaced by 330 Ω (57.10.1331), which results in improved fall and rise times of the chip clock. Modify the label 1.864.170.00 to 1.864.170.81 by hand, e.g. with a permanent marker; this is important for later identification of the assembly.

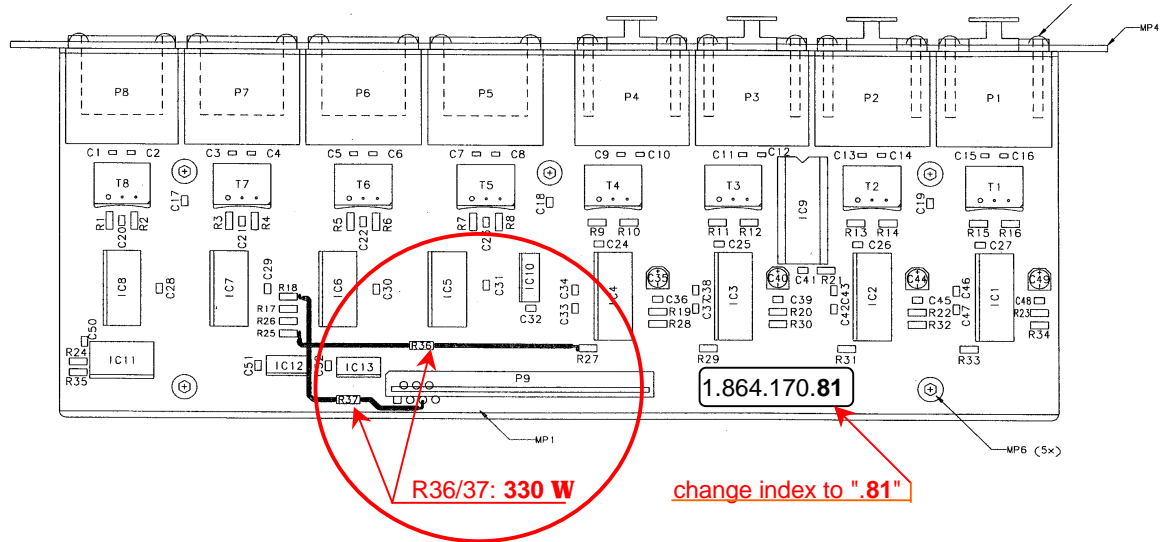
**Position of resistors R36 and R37 on AES/EBU Interface Board 1.864.170.00**

3. The board can now be inserted and connected again. No adjustments are necessary. Perform a function test, i.e., check the AES/EBU input and output by recording and playing back a short session. Reinstall the top cover.
