Modification Instruction for:

* Improvement of frequency response of early 24 channel recorders.

** Elimination of spike noise of A80-VU recorders.

- * Frequency Response 24 Channel
- ** Spike Noise

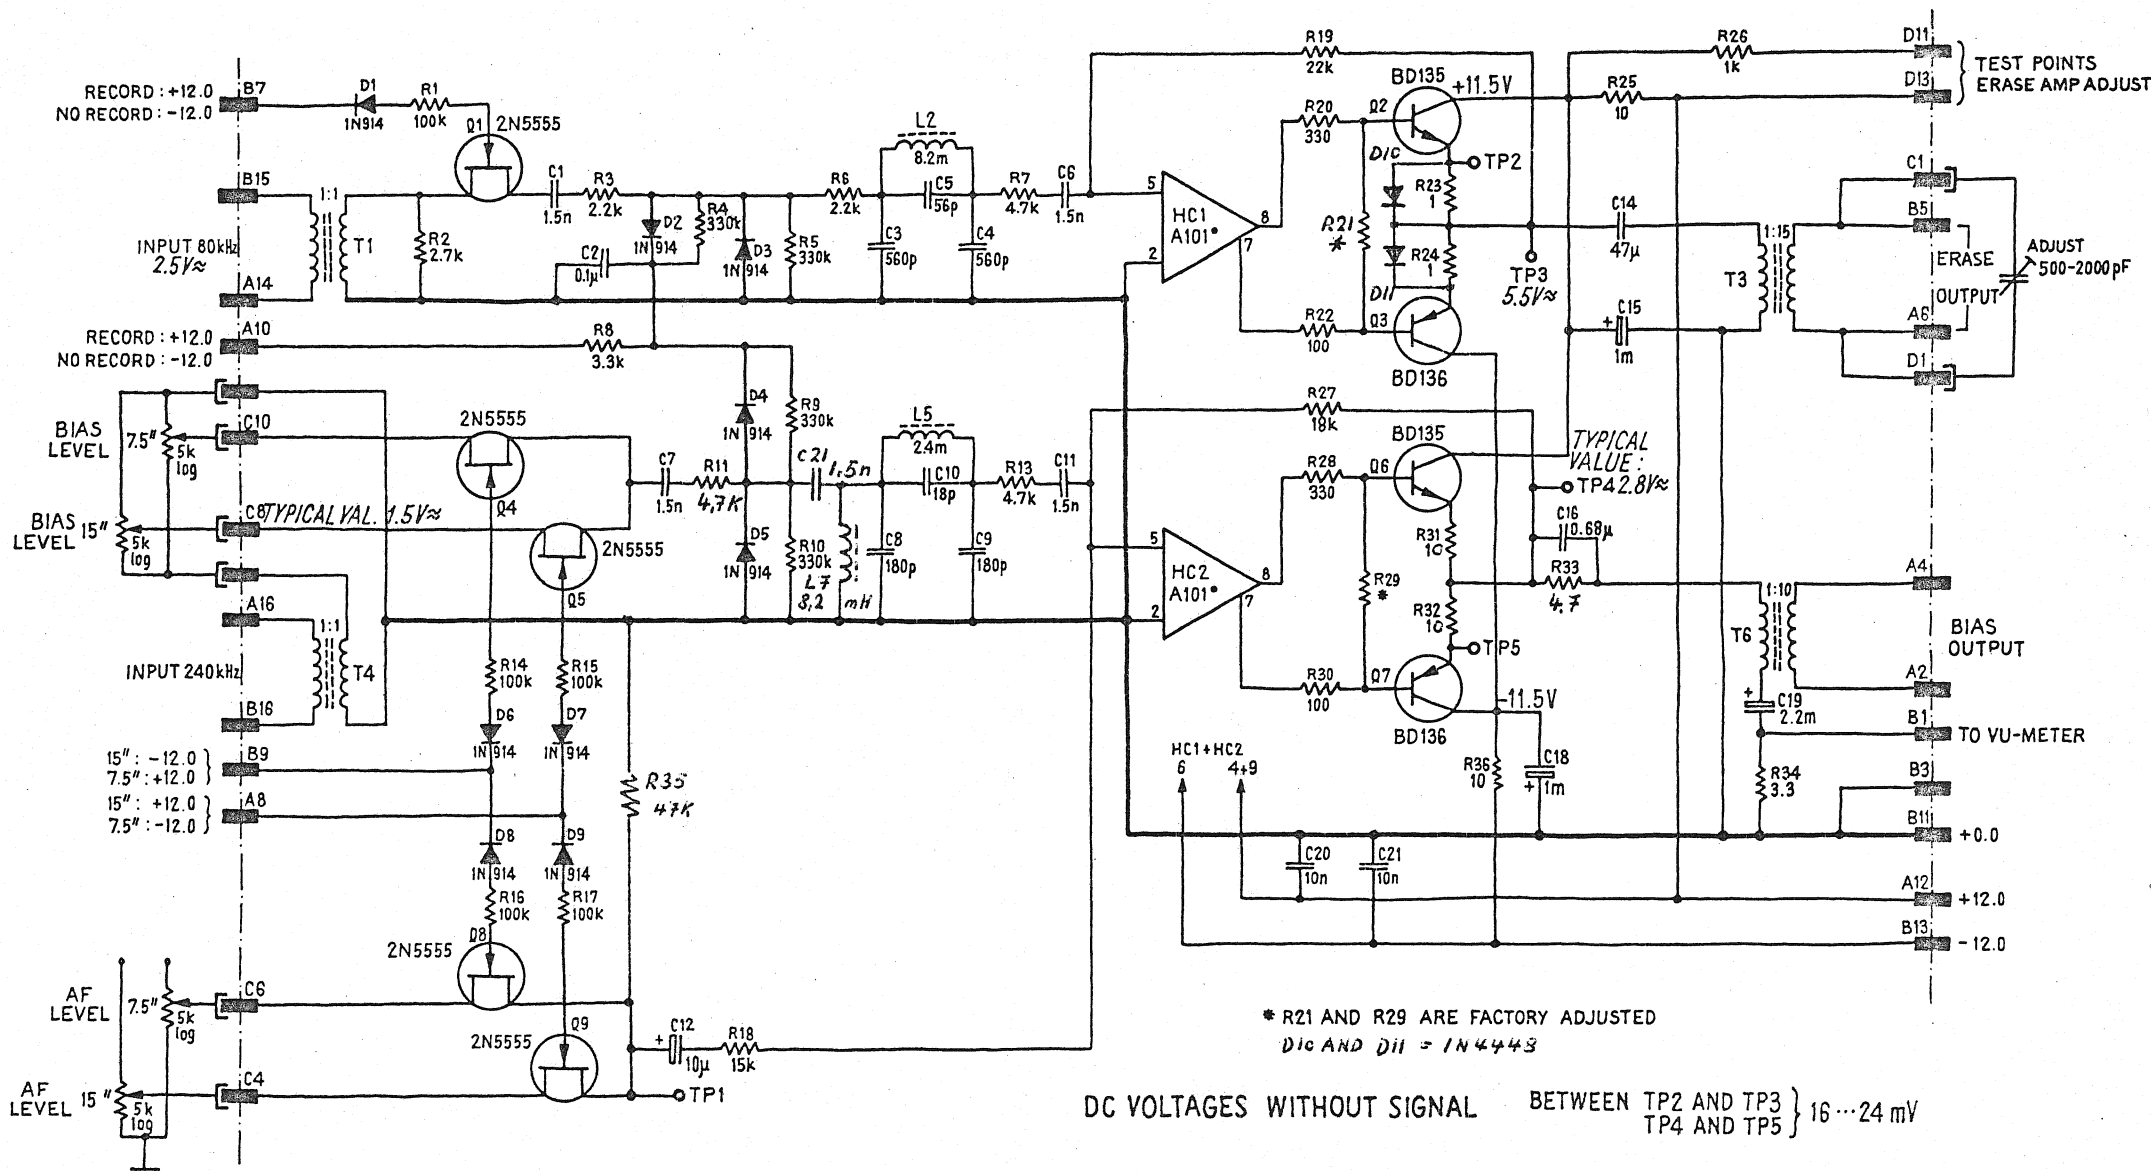
1. It has been found that the early 24 channel A80 recorders have a high frequency roll-off in the reproduce and sync channels. The cause of this short coming has been found in the too low value of the resistor across the secondary winding of the input transformer.

2. Under certain conditions it may occur that 100 Hz spikes are being recorded on the tape. These spikes may be as much as 6 dB above the tape noise.

* substitute 82 KΩ resistor by a 180 KΩ resistor

** Insert additional 8.2 mH choke

** substitute R11 (2.2K)
** by a 4.7K resistor

** substitute R12 (2.2K)
** by a 150pf capacitor

* substitute R33 (10Ω)
* by a 4.7Ω resistor

The 82 K.Ohm resistor near the input transformer T1 must therefore be changed to 180 K.Ohm.

In addition it is recommended to change R33 (10 Ohm) on record driver p.c.b. 1.080.872 to 4,7 Ohm.

This problem can be eliminated by the modifications on the record driver card 1.080.881 marked (**).
